NASA TN D-8006

FRICTION AND WEAR OF
CARBON-GRAPHITE MATERIALS
FOR HIGH-ENERGY BRAKES

Robert C. Bill

Lewis Research Center

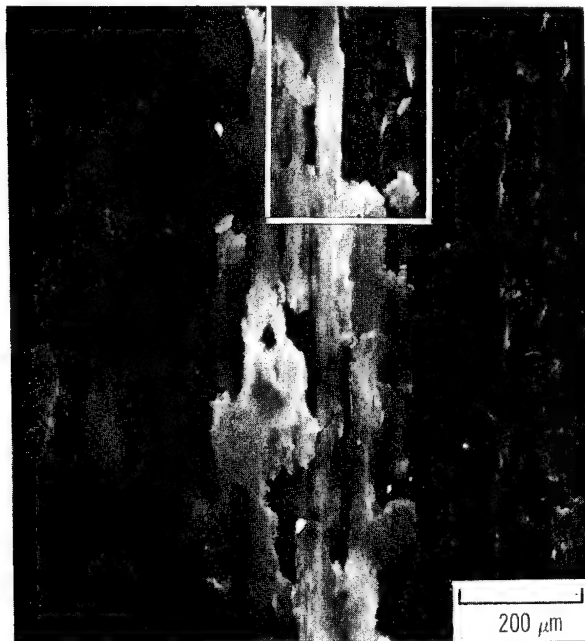
(a) Overview of blistered area.

(b) Enclosed region in (a).

(c) Enclosed region in (b).

Figure 5. - Surface of carbon graphite — low binder (CG-LB) after 1 minute of sliding against a 17-22 AS steel disk at 26 m/sec (83 ft/sec) under a normal load of 422 N (95 lbf).

After exposure to conditions that produced the type of transition described in figure 3, the sliding surface of the carbon-graphite pads showed a distinctly different appearance. On a microscopic scale the sliding surface of the pads showed elongated "blisterlike" features that had a metallic appearance in room light. These features covered about 10 to 20 percent of the surface, the remainder having an appearance like that in figure 4. Examples of these "blistered" areas are shown in figure 5. Here the "blistered" areas are seen to be regions where the shear layer is disrupted; some structural detail is revealed by the way in which the layer breaks up. The shear layer is seen to consist of distinct sheets, probably composed of preferentially oriented graphite. Regions of graphite sheet that have buckled and fractured, with resulting separation from the substrate, are revealed by the "glowing" white areas. The transition to higher friction may then be related to the disruption of a dense, continuous surface shear layer composed of oriented sheets of graphite. According to the literature, disruption can be induced (1) by the desorption of water and other vapors from the shear layer (refs. 6 and 10) and/or (2) by the disruption of the surface oxide present on the metal disk (ref. 9). Once the shear layer is broken up, the pad sliding surface is composed of randomly oriented carbon and graphite particles. Unless the shear layer is restored, sliding will continue to be in a high friction and wear mode.

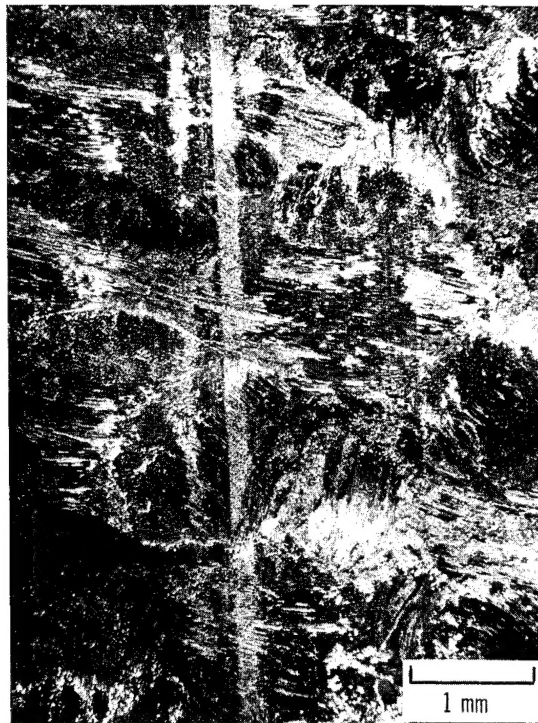
(a) Optical photograph.

(b) Scanning electron micrograph.

Figure 9. - Surface of graphite-cloth-reinforced composite (GCRC) after sliding against a 17-22 AS steel disk in a simulated-stop – speed-variation test.

Friction and wear of graphite-cloth-reinforced composite. - The graphite-cloth-reinforced composite (GCRC) pads were the most wear resistant of the experimental carbon materials when sliding against the 17-22 AS steel disk material. After a sliding exposure, the pad sliding surfaces had a polished appearance with the structure of the graphite cloth apparent, as shown in figure 9. The continuous fiber structure of the composite had remained essentially intact with a continuous film smeared over the sliding surface. Figure 9(b), an SEM photograph, shows the fiber structure barely visible through the surface film.

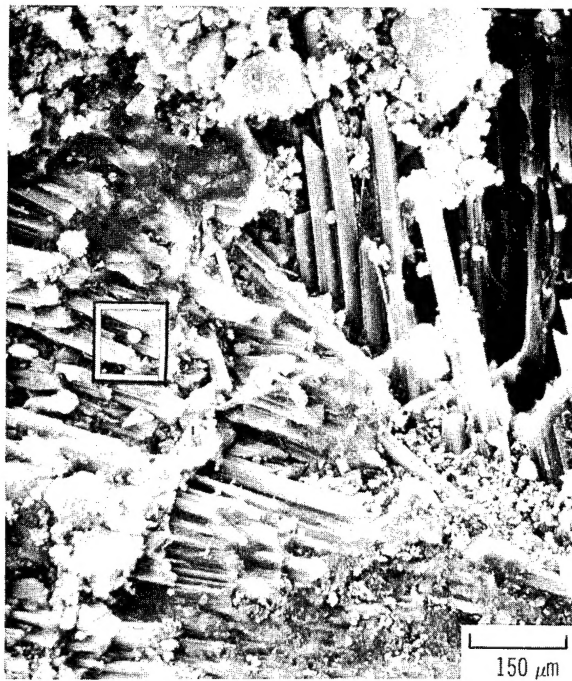
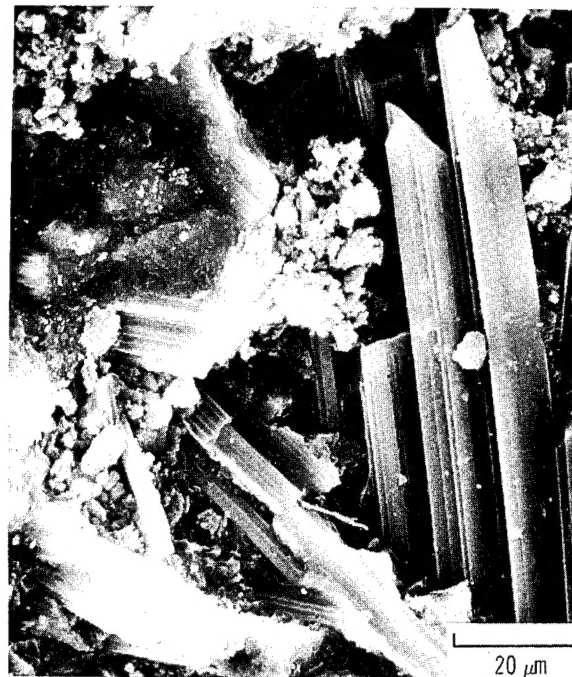
(a) Area of exposed fiber structure.

(b) Region in (a) showing fiber structure of reinforcing cloth.

(c) Enclosed region in (a).

Figure 11. - Surface of graphite-cloth-reinforced composite (GCRC) after sliding against a graphite-cloth-reinforced disk in simulated-stop – speed-variation test shown in figure 10.

shown in figure 10. The severe wear was accompanied by the generation of clouds of loose carbon debris being spewed from the contact area. The condition of the GCRC pad surface after such a sliding exposure was significantly different from that shown in figure 9. Exposed fibers are obvious in the SEM photographs of figure 11. A remarkable feature of the GCRC material shown in these photographs is the very irregular, sharp-edged fiber cross section. The lack of any coherent shear layer on the pad sliding surface is good evidence that fiber exposure ultimately leads to the disruption of this layer. The shape of the fibers and the high mechanical strength associated with them would enable them to act as potentially abrasive constituents on the pad surface.
